# HOLME CULTRAM ABBEY (GHTL15 HCA-B)

## A FINAL REPORT ON ARCHAEOLOGICAL EXCAVATIONS AT HOLME CULTRAM ABBEY SEASON 2015 NGR: NY1774 5075

**Scheduled Monument No. 1007164; County Historic Environment Record No. 3604; 370  
OASIS ID: 1-270999**

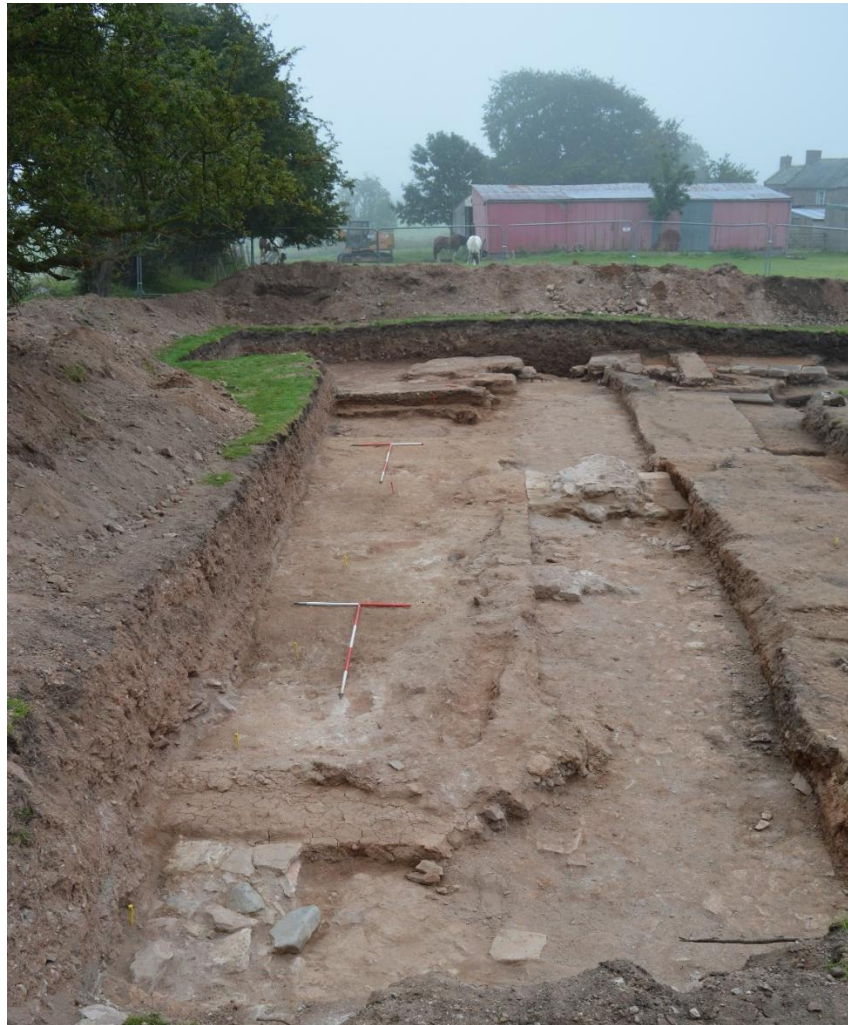
**Plate 1: Trench 1 General view looking south.**

5.1.1 Trench 1 was located on the eastern side of the site, on a slight slope, to the north east of the 2008 trench. It was designed to confirm the position of the Chapter House (2009 evaluation) and further investigate the eastern range and cloister walk; in particular, to uncover any further grave slabs which might have historical significance. In Figure 4 the main archaeological features and deposits observed can be seen. Discussion of Trench 1 below relates mainly to this plan.

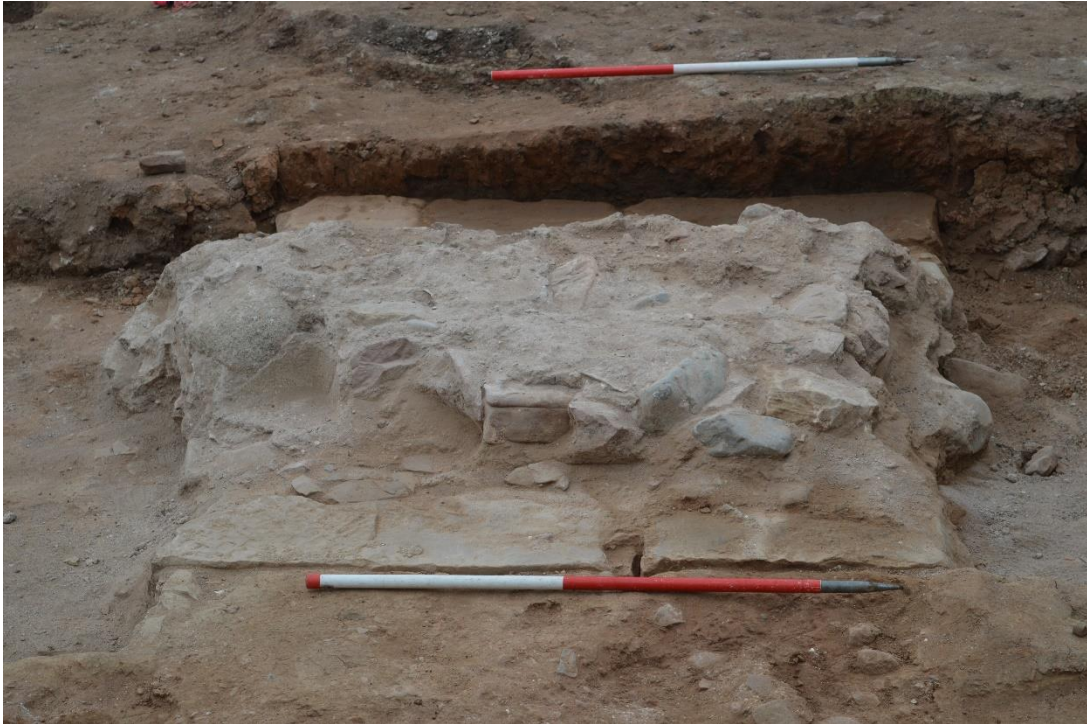
**Plate 2: Close up of wall core (114) post clean (facing west)**

5.1.2 The West wall of the East range survives only as a robber trench with one portion of intact foundation and core remaining (114). The trench was filled with post Dissolution debris. Facing stones survive on both sides of the surviving wall remnant (114) though these are at foundation level. The west wall runs North South across the trench. Very few of the sandstone blocks remain as they have been robbed out. The foundations were large cobbles (405) levelled with fragments of sandstone and chipping debris (404) to form the base for the East range wall (114). The foundations for the day stairs survive (199) beneath a mortar rich layer (102) and demolition layer (149). The foundations consist of large sandstone slabs with a heat affected clay deposit to the West which may represent a floor level (400). A robbed out drain cuts through this area east - west [198] containing (122), a sandy matrix interpreted as a mixture of demolition material and drain fill. Five small finds were recovered from this context: SF20, 68, 72, 76, 128. Three sherds of pottery were recovered dating from 14<sup>th</sup> -17<sup>th</sup> centuries. The same drain was recorded to the west of the robbed-out Chapter House wall [109] in a state of good preservation with intact capstones (128). The capstones appear to be higher than the surrounding floor surfaces and the drain runs through the south-east corner of the Cloister Walk. The crude nature of the capstones combined with higher elevation suggests that this is a later structure, perhaps addressing draining issues within the Cloister Garth. The drain contained a moist grey brown fill (134) from which SF# 151 was recovered.

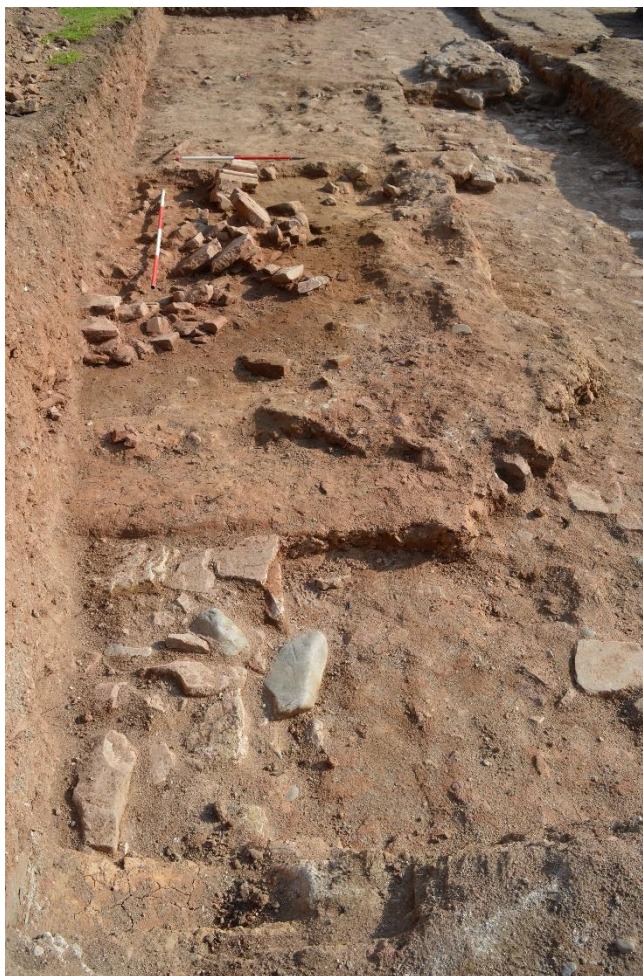
**Plate 3: (111) and (113) in Chapter House (facing south)**

5.1.8 The interior of the chapter house was excavated to natural clay (101) with no intact floor surfaces surviving. A large amount of demolition rubble, including a number of floor tiles were recovered from this area (111, 112). Upon further excavation, these deposits were found to overly a disturbed grave [173]. The grave fill consisted of rubble and broken floor tile. However, at the western extent of the cut a fragment of human pelvis overlay a fragment of human skull. These were not exhumed but photographed in-situ and re-buried. The identification of a burial within this building, along with the position within the eastern range, is strong evidence of function at The Chapter House. The disturbed nature of the grave, backfilled with building rubble and disarticulated human bone, is suggestive of post-dissolution 'treasure hunting' rather than careful exhumation and reburial. The thorough nature of the stone robbing in Trench 1 shows the extent to which the raw materials used to build the monastery were valued and 'recycled' post-dissolution. The tip lines of rubble noted in the eastern section suggest that the area of the chapter house was, for some time post-dissolution, left open as a robbed feature, allowing a water carried silt deposit (112) to form above the natural clay. Sometime later, a large quantity of building rubble was used to fill in this depression, as evidenced by the tip lines of dumping material within (104) from both the north and south end of the trench shown in Figure 5, Section 5. This would be a logical act of 'landscaping' following the robbing of stone to return the field to a useable state. It is not possible to ascertain why a small portion of wall survived the campaign of stone robbing, or why the archaeological preservation was so good in the south west corner of the trench. One possibility is that these areas lay beneath the spoil heaps generated by the demolition and robbing activity, thus leading to small pockets of preservation.

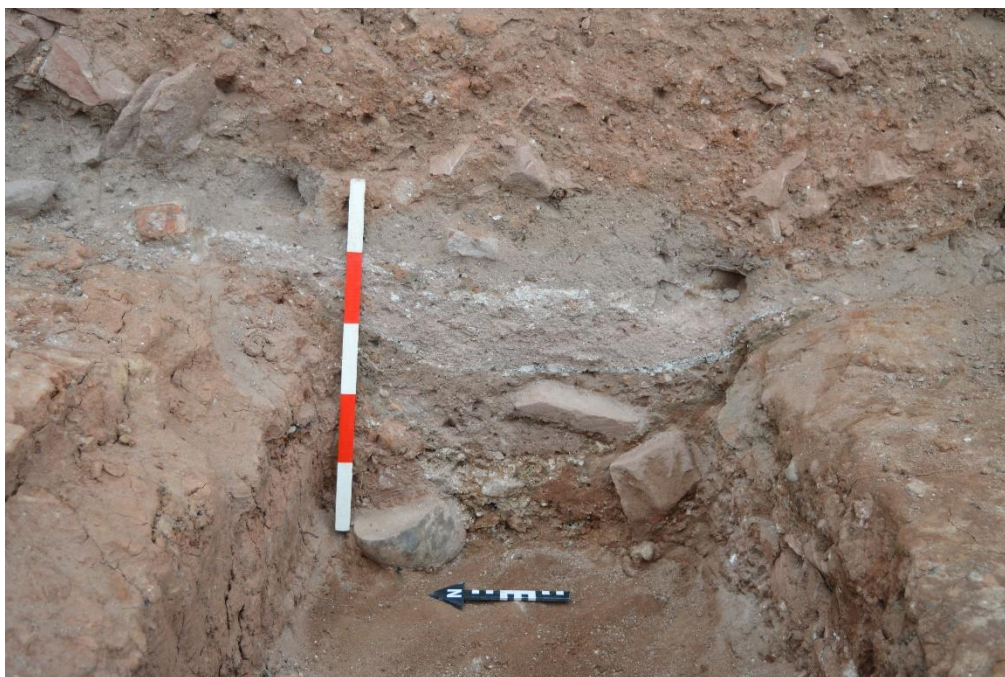
**Plate 4: [173] (174) grave cut and fill in Chapter House (411) and (412) (facing east)**

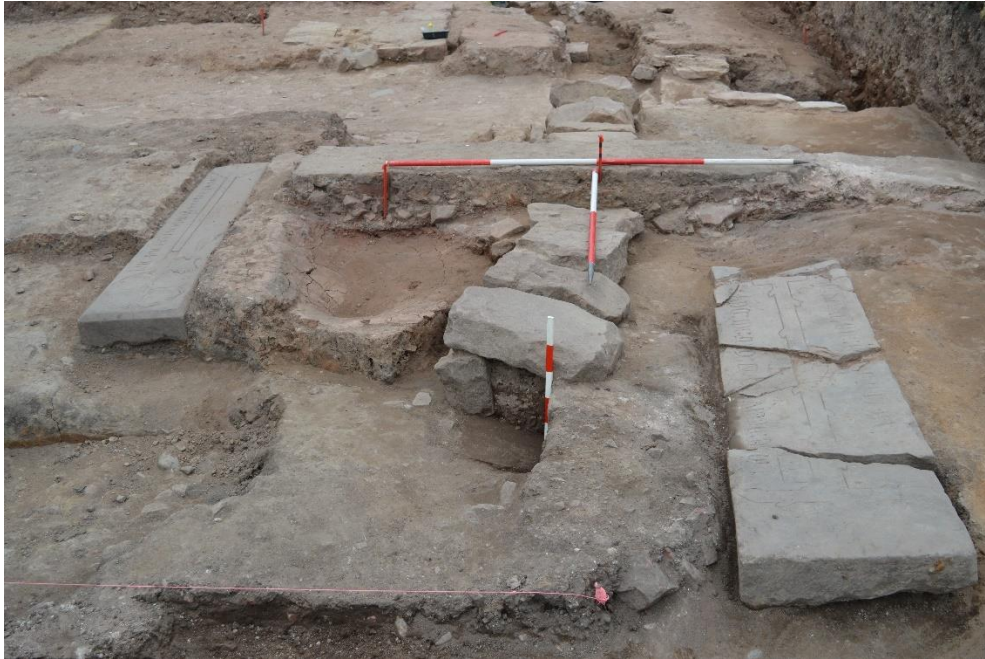
**Plate 5:** East facing view of the south west corner of trench 1. Grave slab (106) is in the right foreground located in the south cloister walk. In the centre of the image is the stone lined drain (128) and to the left grave slab (107) can be seen in the east cloister walk. The drain runs through the south east corner of the cloister walk.

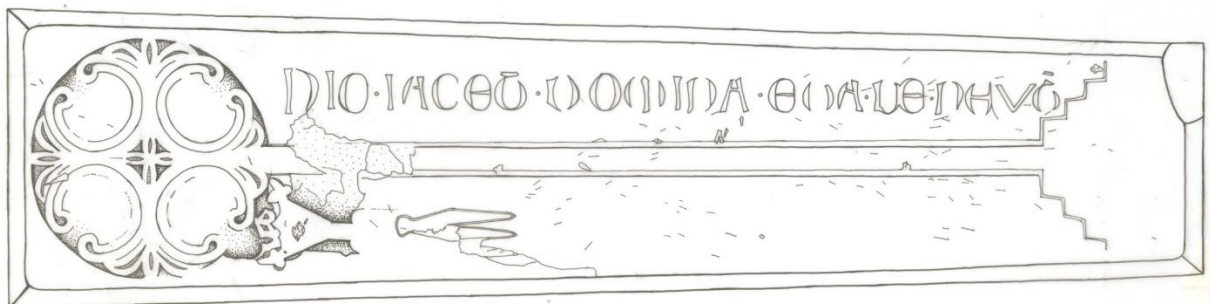
**Illustration I:** Grave slab (107). Drawn by Hayley Graham

- (2)The northern slab, 1.81 m long and 0.46 m wide at the head, tapering to 0.32 m. Chamfered around the edge, it is also of red sandstone, but in much better condition. The design is incised, except for some low relief and sunk panels around the head. The cross head, carved within a circle, is of round-leaf bracelet form, with fleur-de-lys buds and a small cross at the head centre; it rises from a stepped Calvary base. On the l. of the shaft immediately below the head is what appears to be a unique emblem, a vase or cup from which three fleur-de-lys spring; it has the look of being a secondary addition to the design, with small cusped panels between it and the cross head looking of 14<sup>th</sup>-century character; directly below is a second emblem, this time lightly incised, a pair of shears, shown in outline only.

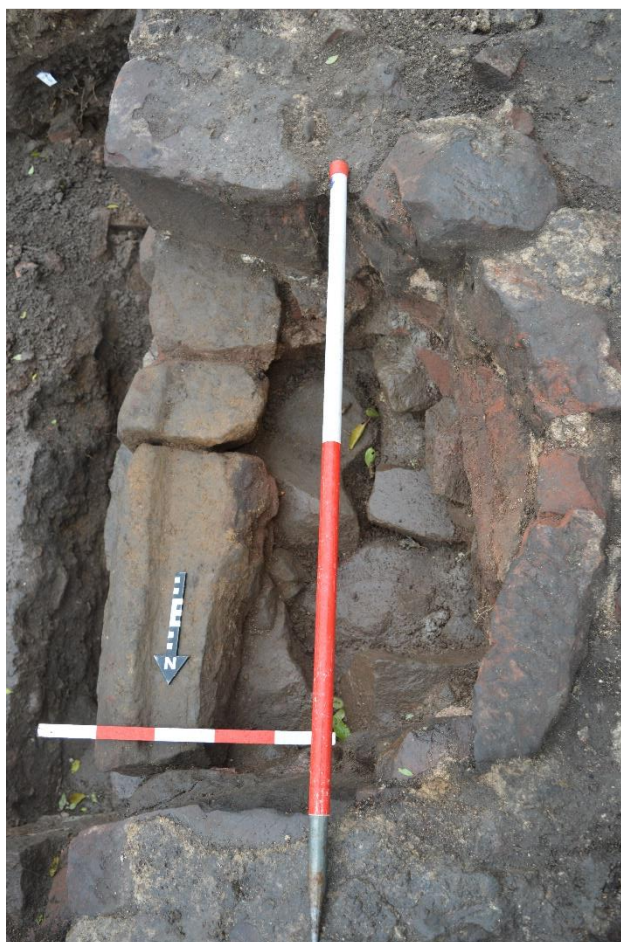
**Plate 6: Fireplace (287) post excavation (facing south)**

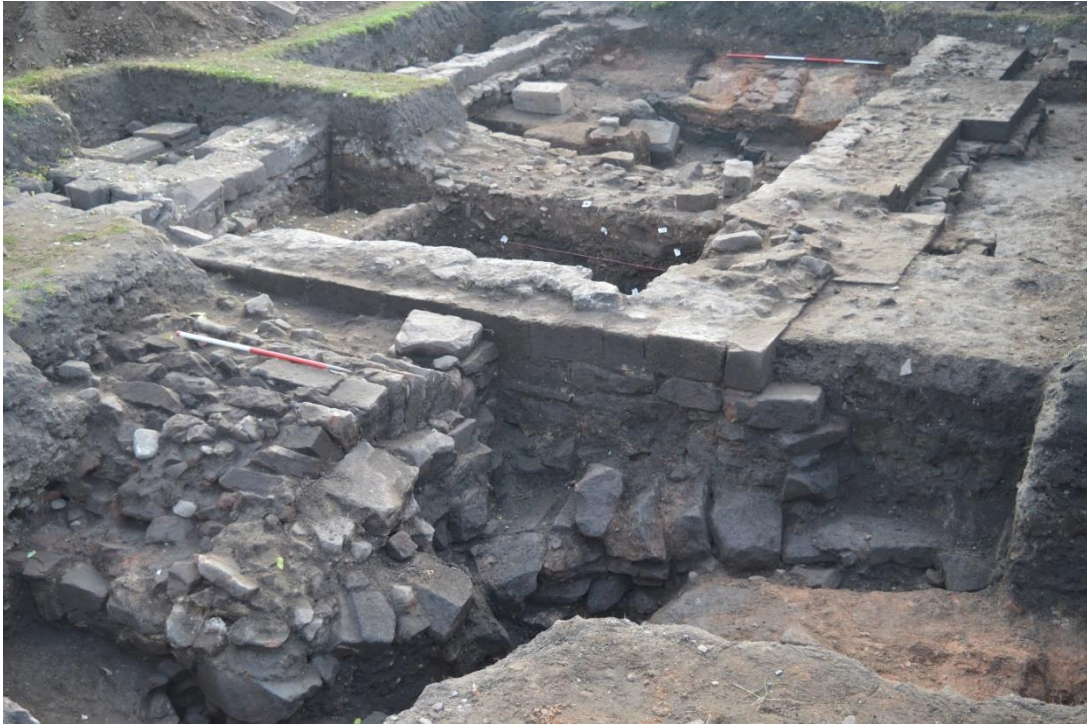
**Plate 7: General view of trench 2 looking south. The back of the cistern (211) is in the foreground with the south culvert (219) beneath the corner of the building (217). The hearth (233) in the south room is visible in the top right of the image.**

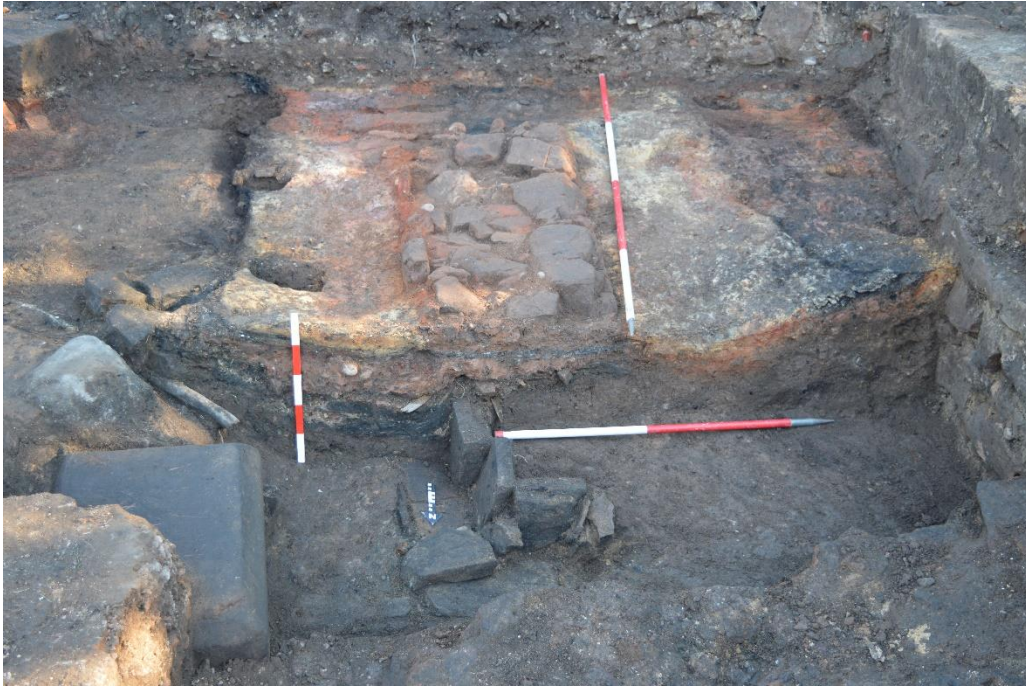
**Plate 8: South facing view of the south room in trench 2. The central rectangular hearth (233) of stone and clay is in the upper centre of the image with heat affected clay and burnt midden material to the east and west. The north facing section shows earlier deposits beneath the floor surface including the drain (258) beneath the hearth. The lead pipe can be seen on the left side of the photo.**

5.2.7 In the southern room a stone and clay hearth was uncovered (233) with associated heat affected clay surfaces and midden material (207), (230), (231), (264) and (250). These surfaces and hearth had slumped in the centre of the building and lay below the foundation level of the walls (216), (203).

5.2.8 Drain (258) was uncovered running North - South below hearth (233) and a dump of stone roofing material to the north (261). The drain comprised of edge stones (283), capstones (301) and a stone base (258). Further north, the base was made of tile (284). A length of lead water pipe was also uncovered beneath the floor surface layers, running from the east wall (216) to the drain (258).

5.2.9 Cut into the heat affected surface layers were three postholes (235, 236, 237). Post hole (237) cut through the underlying lead pipe. The hearth (233) and associated burning and midden deposits are contemporary with the occupation of the building, whereas the drain (258), lead pipe and all underlying deposits pre-date the building and relate to a large cut feature into the natural and the subsequent infilling and use of this feature for water management. The section drawing shown in Figure 8 shows the stone foundation of the partition wall (210) and the sequence of deposits underneath which pre-date the building. Organic rich deposits were encountered in the sequence below the building and were sampled. The building overlies a deep cut into the natural [329] which may have been for material extraction during a construction phase at the abbey and/or to provide a pond relating to water management.

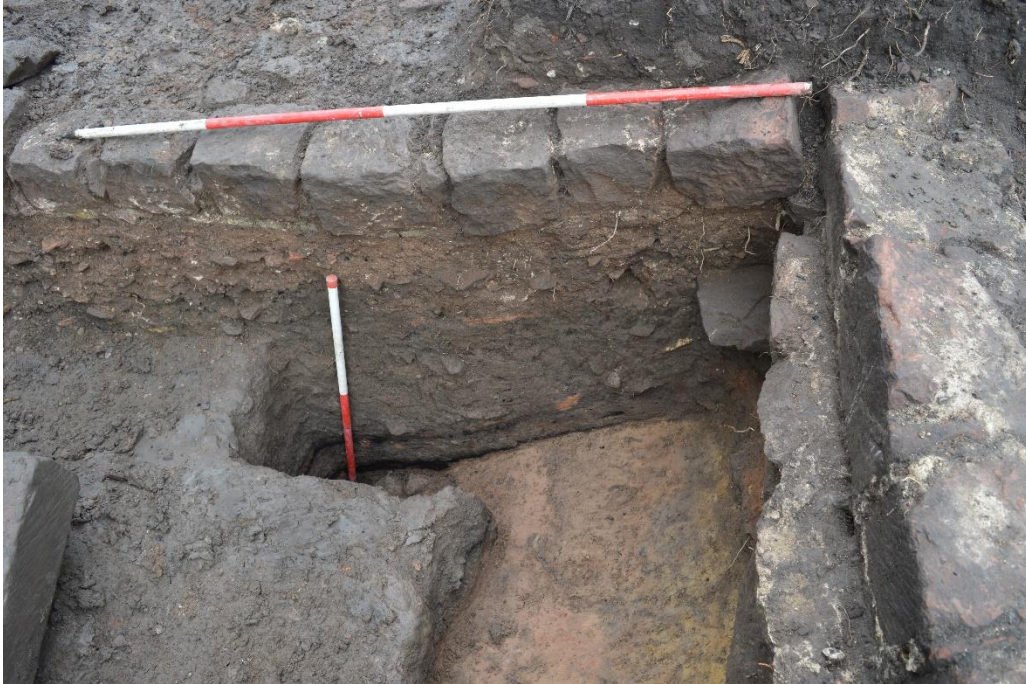
**Plate 9: Showing on edge of large cut [329] in natural below (210), showing (205) (254) (294) (facing south)**

5.2.10 The construction of the building over a previously cut and backfilled feature explains the difference in wall thicknesses observed in the building construction. The east wall (216) was a little over 0.6m wide and required no additional supports. This wall sits on the natural clay on the edge of, and parallel to, the earlier cut feature or pond [329]. In contrast, the western wall (203) is constructed within the cut feature, meaning that the wall is cut into soft backfill material (254). The foundations are much deeper and could not be fully excavated. The wall width is also wider than the eastern wall and two buttresses were constructed on the western face of the wall, contemporary with the construction of the building, to provide further support for what must have been a two-story building. The northern room would likely have an upper floor and a timber or wattle and daub partition constructed on a stone foundation (210), whilst the southern room, with open central hearth, would have been open to the rafters.

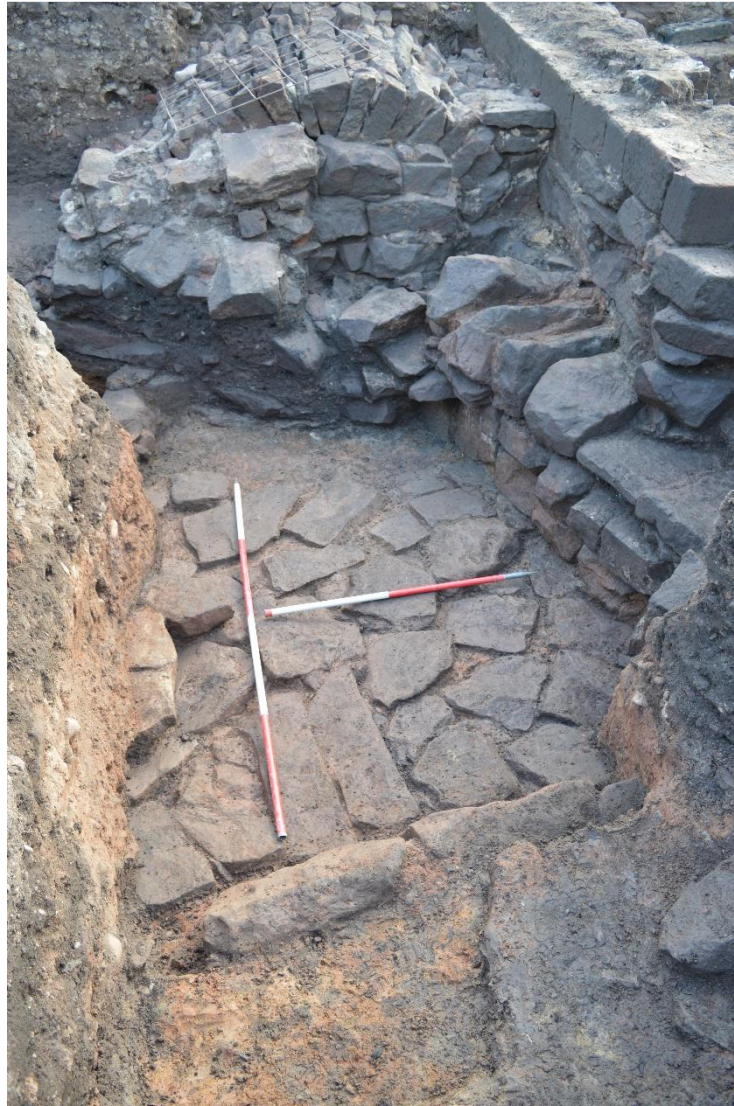
**Plate 10: Cut feature [330] with stone lined base (307), which was covered by (228), which was then cut by [275] for the construction of culverts (276), (219) and cistern (211). The building walls (203), (217) were then constructed, with the corner of these two walls overlying the southern culvert (219). (facing east)**

5.2.11 The area to the west of the cistern (211) excavated in 2014 beyond the north-west corner of the building was also investigated. The earliest phase of activity in this area was represented by a cut into the natural clay [330]. This flat-bottomed cut feature was then lined with flat stones in the base (307). Cut [330] is parallel to cut [329] identified in the north-west corner of the southern room underlying wall (216) and may represent the west side of the same cut feature. This may have been an early feature of the water management system on the site, perhaps a pond or lined water tank. The next phase of activity in this area is the deposit of orange sandy clay (288) to fill in the cut and cover the stone base. This deposit was then cut into [275] for the construction of the two water culverts (276), (219) and the cistern (211). The building walls (203), (217) were then constructed, with the corner of these two walls overlying the southern culvert (219).

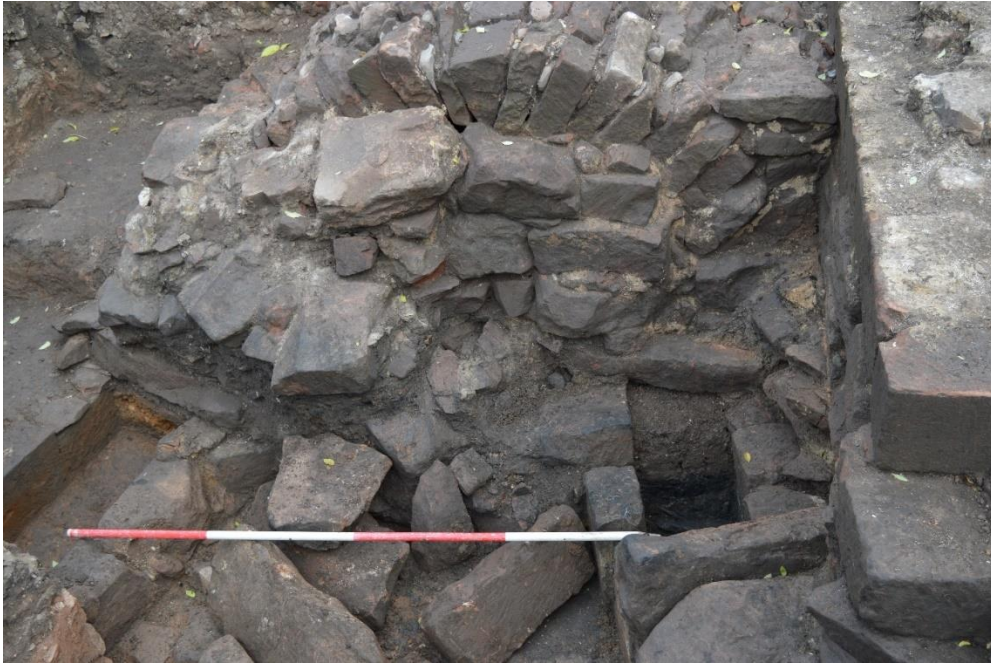
**Plate 11: East facing view of the back of the cistern (211) showing water culverts (276 left) and (279 right). Note the difference in colour of deposits feeding into the cistern with the north culvert (276) being orange and iron rich compared to the organic rich black material in the south culvert (219). The contents of these culverts have been sampled. Note also that the building corner on the right of the image shows the north wall (217) constructed on top of the culvert.**

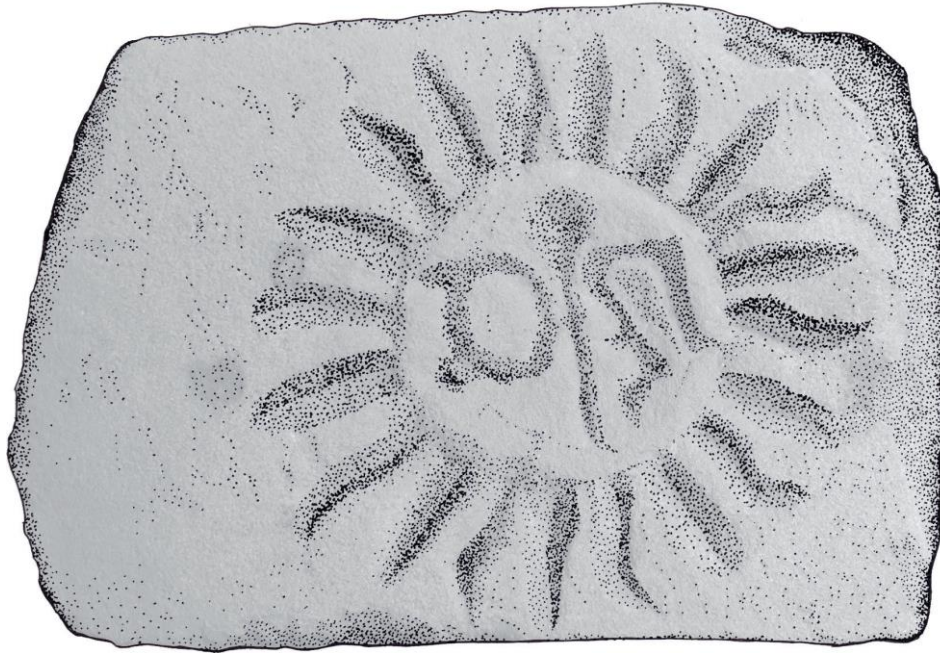
**Illustration 3: Carved stone showing initials (DN?) within a sun in splendor. When reversed, the initials appear RC, separated by a staff. Drawn by Marilyn Leech**

6.2.3 Notable finds include an engraved stone, found in the possible Abbot's lodging. It is concave, and may have been used as a mould. It shows a sun surrounding letters which may read DN - Dominus Noster (Our Lord), the sun representing 'a sun in splendour' the symbol adopted by Edward IV following the Battle of Mortimer's Cross, 1461. Alternatively, if used as a mould, the letters could be the initials of Robert Chambers, Abbot at Holme Cultram Abbey 1507-1518.

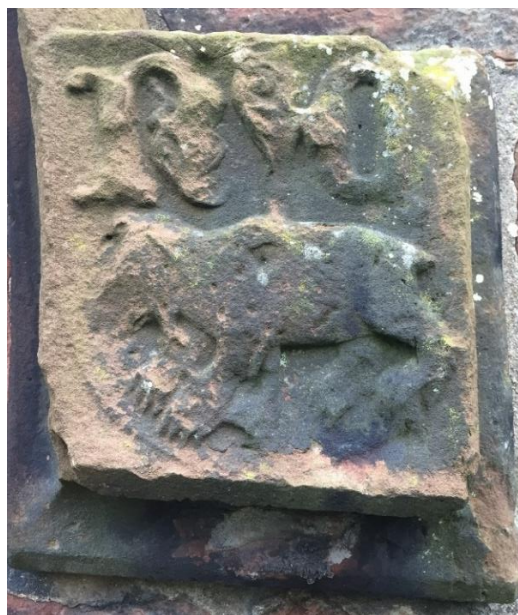
**Plate 12: Carved stone on the abbey porch showing chained bear and initials of Robert Chambers separated by a staff or crozier.**

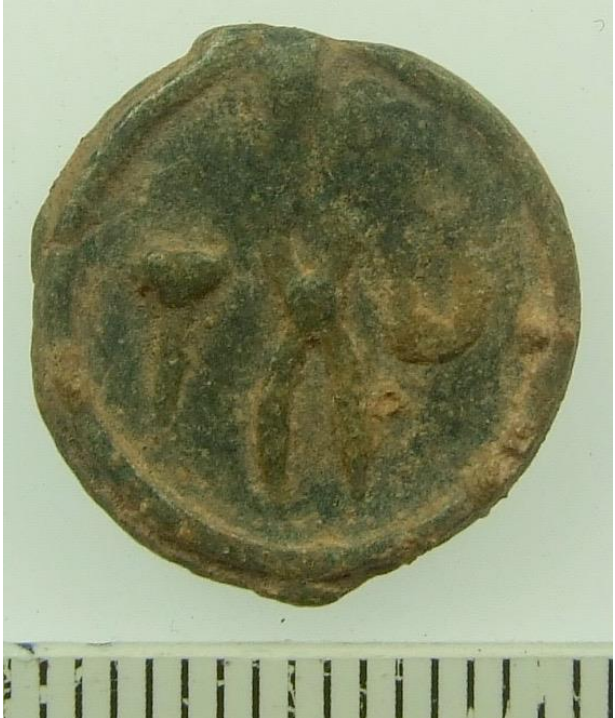
| Image | Reference & Details |
|---|---|
| | <p><u>Figure 1</u></p> <p>Small Finds Reference 24, Obverse</p> <p>Description: Hammer, tongs and horse-shoe</p> <p>Powell Classification Type 21: Inanimate Objects</p> <p>Number of this design found: 3</p> |

Figures 1-12 below shows the six types of tokens found and uses the Powell Classification system for lead tokens to describe them ([http://www.mernick.org.uk/leadtokens/Classification\\_System.pdf](http://www.mernick.org.uk/leadtokens/Classification_System.pdf)). One item (the crowned R piece) is quite different from the rest of the series and may be better classified as a seal or pilgrim badge. This will be further discussed later. For ease of reference, the face with the image is referred to as the 'obverse' and that with lettering as the 'reverse', although there is no way to tell if this nomenclature is correct.

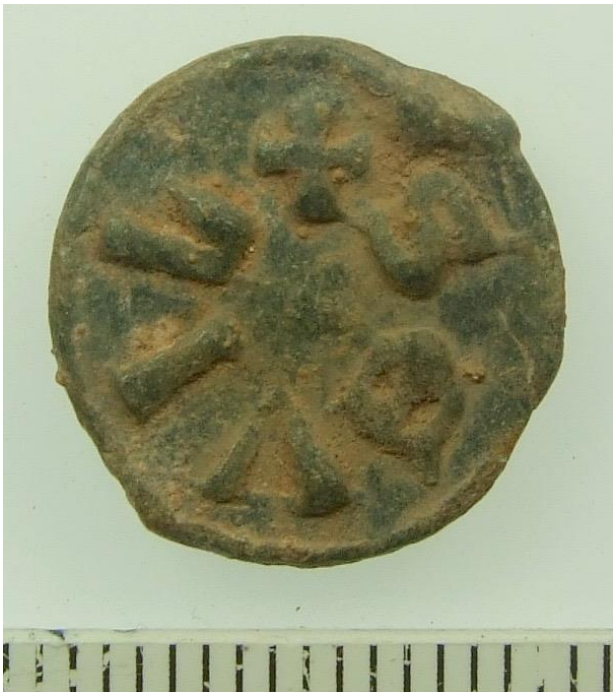
| Image | Reference & Details |
|---|---|
| | <p><u>Figure 2</u></p> <p>Small Finds Reference 24, Reverse</p> <p>Description: The letters SEVIL+</p> <p>Powell Classification Type 29: Words or significant abbreviations</p> |

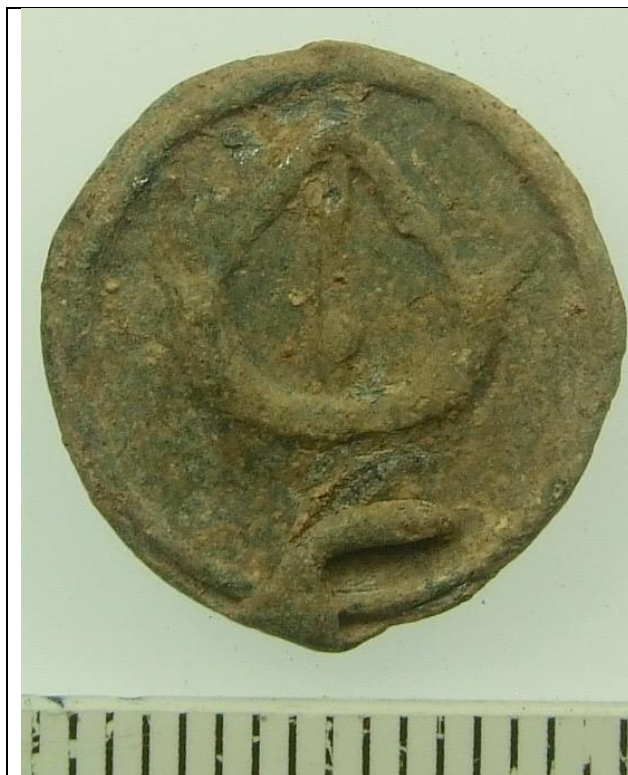
Figure 3

Small Finds Reference 56, Obverse

Powell Classification Type depends on interpretation of the diagram. If a ship, then this is type 6; if scales or a salt pan, then

Number of this design found: 30

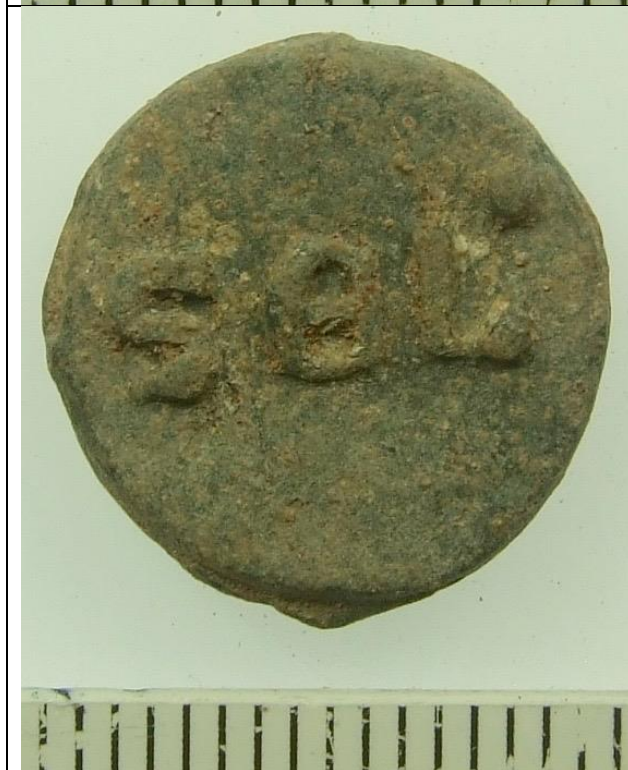
Figure 4

Small Finds Reference 56, Reverse

Powell Classification Type 29: Words or significant abbreviations

Description: The letters SEL followed by a superscript dot

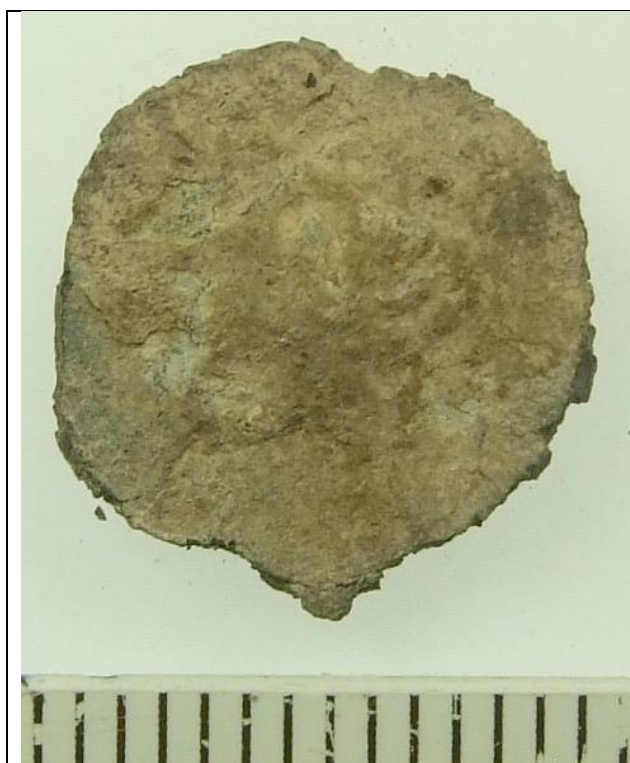
Figure 5

Small Finds Reference 71, Obverse

Description: A flower with five petals

Number of this design found: 1 possibly 2

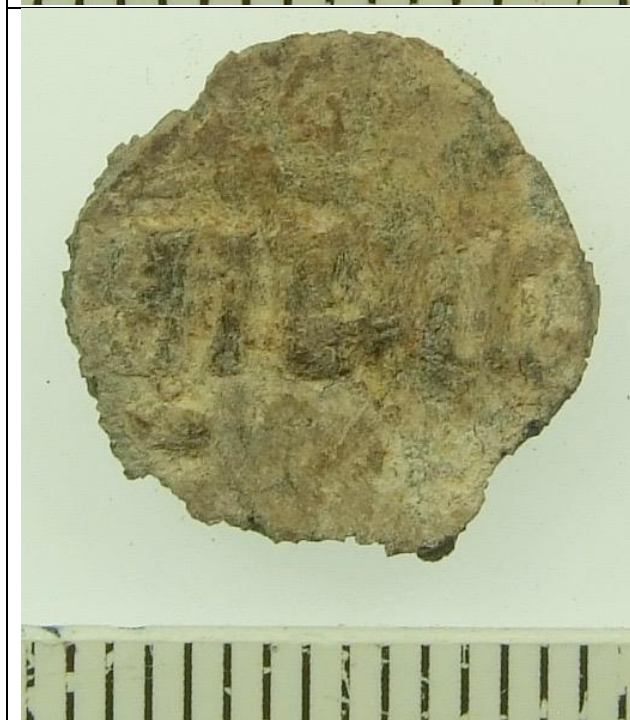
Figure 6

Small Finds Reference 71, Reverse

Powell Classification Type 29: Words or significant abbreviations

Description: Lettering apparent but indecipherable. Possibly INLE or ?HIC.

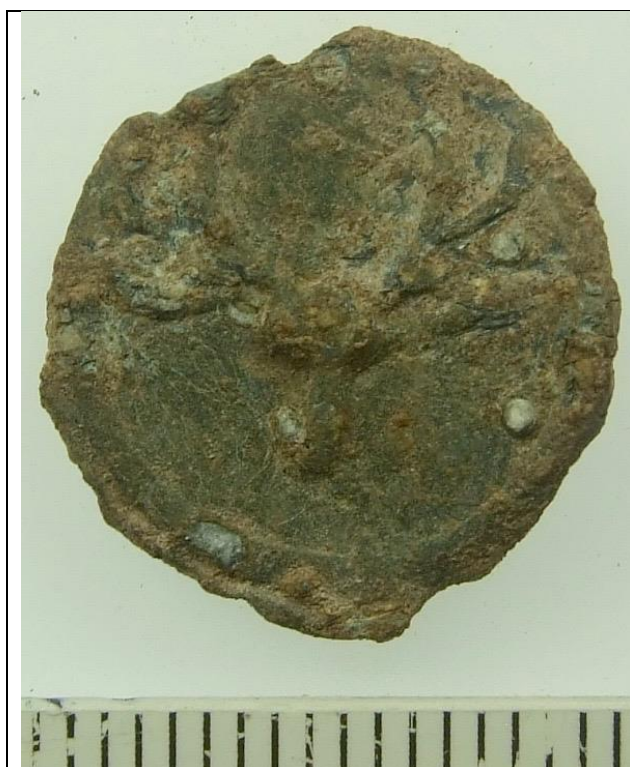
Figure 7

Small Finds Reference 65, Obverse

Description: A pollarded tree or possibly a stag's head with antlers.

Number of this design found: 2

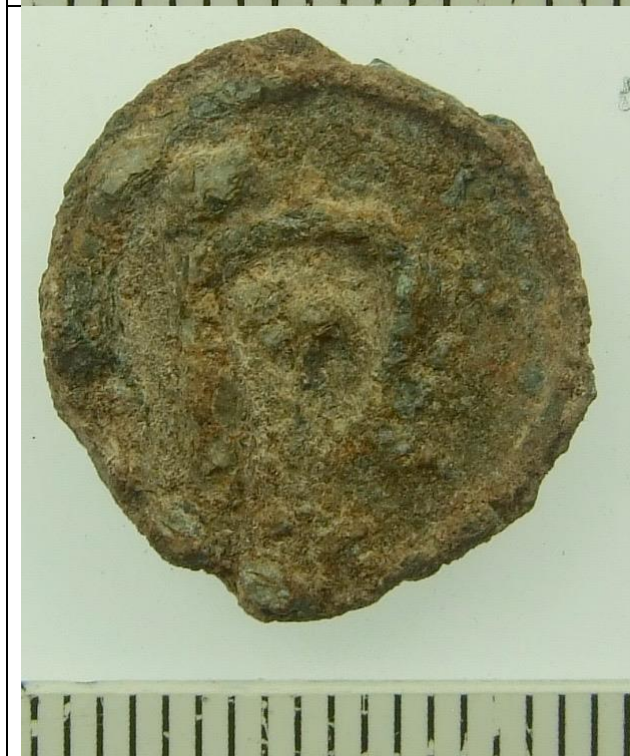
Figure 8

Small Finds Reference 65, Reverse

Powell Classification Type 29: Words or significant abbreviations or Type 15: Religious

Description: Possibly a 'h' with a dot in the middle; possibly a crozier

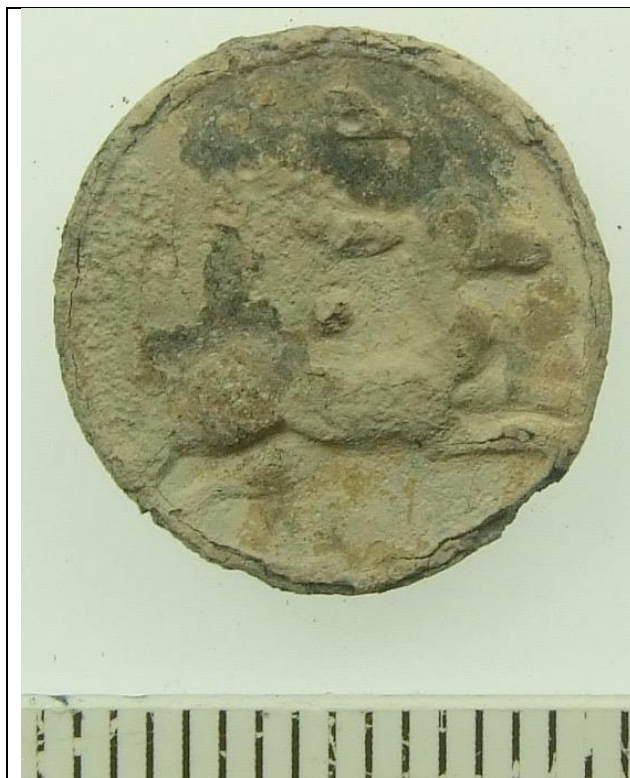
Figure 9

Small Finds Reference 63, Obverse

Description: A leaping stag

Number of this design found: 1

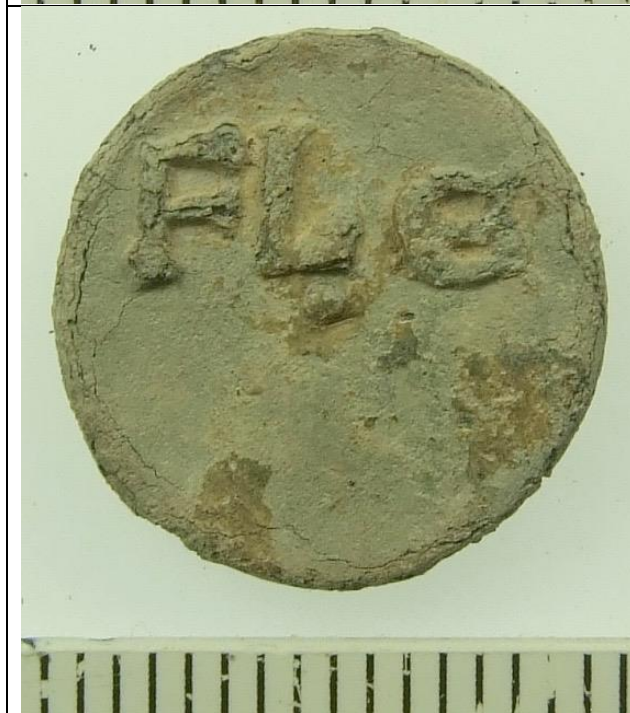
Figure 10

Small Finds Reference 63, Reverse

Powell Classification Type 29: Words or significant abbreviations

Description: The letters FLE with a subscript dot beneath the 'L'.

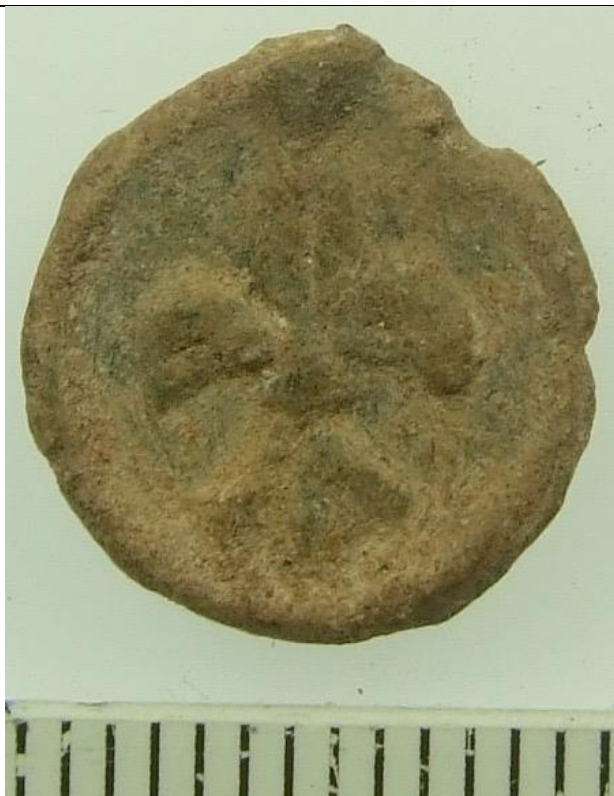
Figure 11

Small Finds Reference 31, Obverse

Description: Fleur de lys

Number of this design found: 2, possibly 3

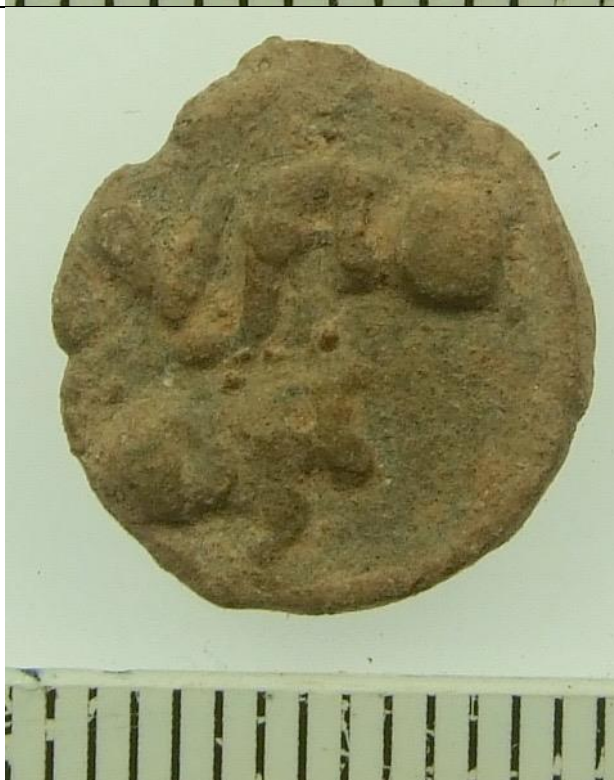
Figure 12

Small Finds Reference 31, Reverse

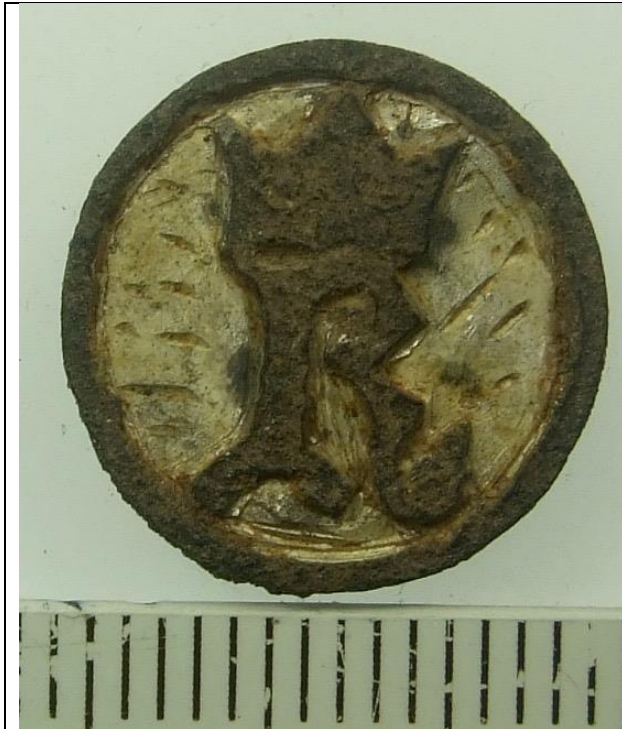
Small Finds Reference 16

Description: A crowned 'R'

Number of this design found: 1

The artefact shown in Figure 13 and 14 is quite different to the tokens described above. It is made of lead or pewter and is of a comparable size to the tokens but the designs feature on the obverse only, with the reverse remaining blank. Stylistically, it is different to the other tokens in that not only is the design raised but it is also incised so there has been a secondary activity in the design and decoration process. Similar designs are found on finger rings in the medieval period, thought to be seals (Murrawski 2003, 410-413). A crowned 'R' is found in the Jerusalem Chamber of the Cheneygates (the medieval house of the Abbots of Westminster) and is thought

to be the royal cypher of Richard II in whose reign the chamber was constructed. There are a number of associations with royal 'R's' in the charter evidence, notably in connection with grants of forestry at Inglewood (Grainger and Collingwood 1929, 45-7) although no evidence that there was ever a closer link. The abbey does have a link with a Scottish royal 'R' in that it is the resting place for the body of the father of King Robert the Bruce but again, there is no suggestion of patronage or affiliation in any other way. A further suggestion is that the crowned R stands for 'Regina Coeli', or Mary Queen of Heaven. The abbey's seal features the Virgin Mary standing (Gilbanks 1899,88) and so an association with Mary is known but this interpretation of the artefact cannot yet be substantiated.

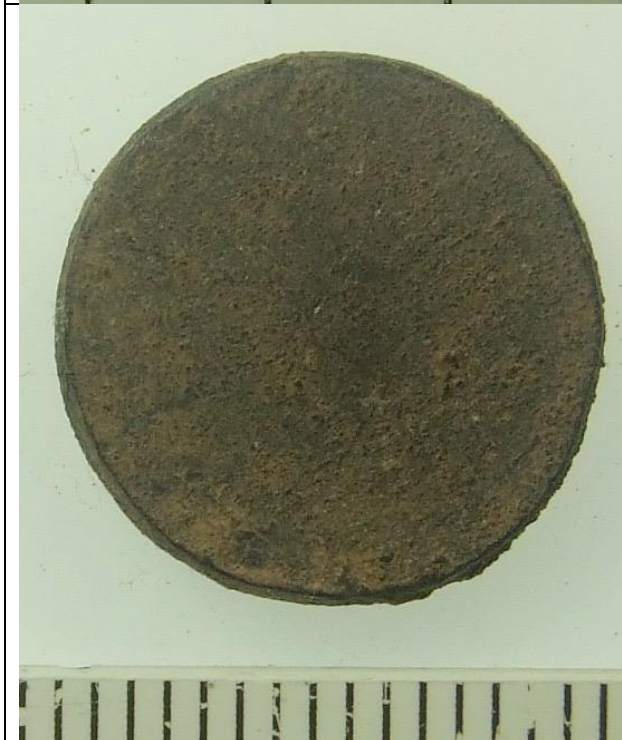
Figure 14 – Small Finds Reference 16

Description: Reverse, undecorated.
